## **REPORT OF MARINE SURVEY**

### **PRE-PURCHASE CONDITION & VALUE of the vessel**

**" Honey Bunny"  
1984 S2 center cockpit**

**John M. Hughes  
on  
February 1 and 2, 2013**

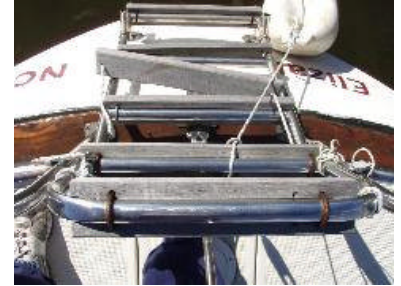
<b>Transom type:</b>	Conventional transom.
<b>Moisture/Delamination:</b>	All moisture meter readings on transom and surrounding thru hull fittings were relatively dry with normal comparative moisture meter readings.
<b>Stress cracks:</b>	None sighted.
<b>Transom thru hull fittings:</b>	All well secured and functional.
<b>Swim/Boarding ladder:</b>	The boarding ladder is stainless steel that is mounted on transom. The ladder rungs have teak steps secured with rusty u-bolts. <b>One step is missing u-bolt and partly adrift.</b>

One step is missing u-bolt and partly adrift.

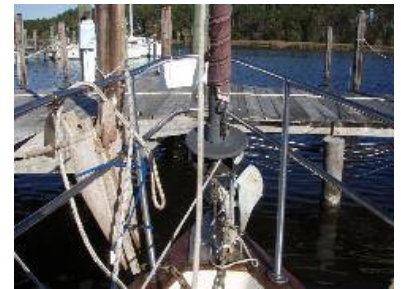
- Bow pulpit/rail:** Stainless steel Bow pulpit is secure, however slightly askew toward port side indicating previous impact.

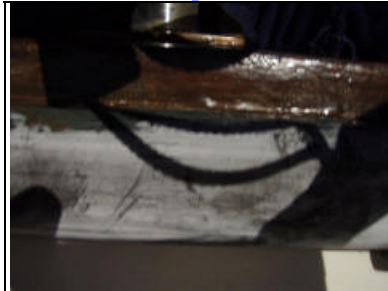
- Stanchions/side rail(s):** Stainless steel and well secured. One stanchion on port side (#3 counted from forward) is slightly bent and distorted at base plate. Recommend removal in order to fair out base plate, stanchion and re-bed.

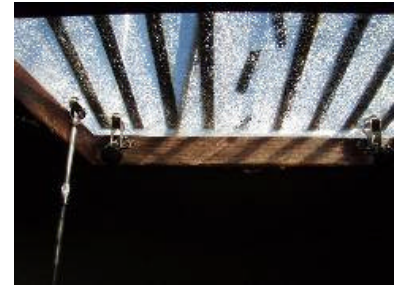
- Lifeline(s):** Life lines have some areas where rust has developed near end connections. **RECOMMENDATION:** At the first sign of any such problem all lifelines should be replaced for safety reasons.
- Cleats & fairleads:** Horn cleats are all well secured to deck and side deck and are functional.
- Escape hatch(es):** Forward main cabin top escape hatch has crazed glass and broken support arm. The gasket is broken and partly adrift with evidence of leaking inside. **RECOMMENDATION:** Repair or replace as necessary.

Life lines have some areas where rust has developed near end connections. RECOMMENDATION: At the first sign of any such problem all lifelines should be replaced for safety reasons.

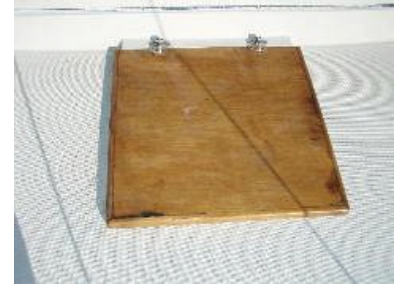
Aft cabin escape hatch has been replaced with wood rather than clear plexiglas.

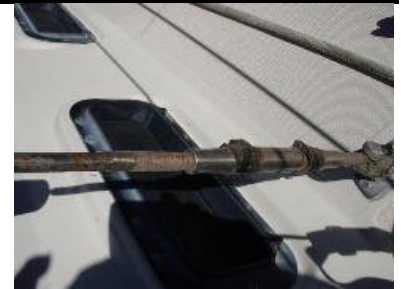
**Material & Condition:** Stainless steel wire and connections. Some corrosion (rust) sighted. **RECOMMENDATION:** Corrosion could indicate a weakened condition of stay, swage fittings and turnbuckles. Considering vessel's age, detailed inspection by qualified rigger is recommended and replacement as deemed necessary.

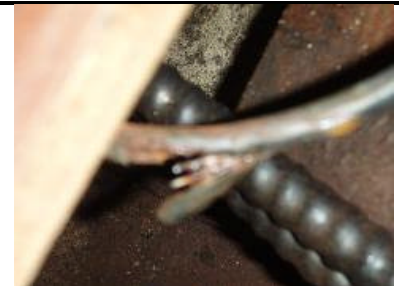
**Throttle and shift controls:** Separate levers for each engine throttle and shift control. Shift control cable cover is breached; cable should be renewed.

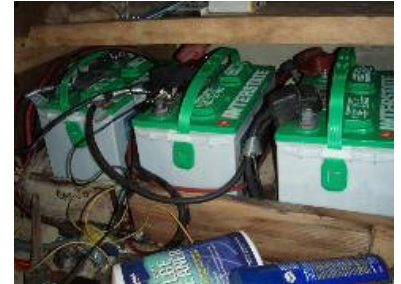
**Primary batteries:** Batteries not fully secured. Positive terminal(s) not covered as required. **RECOMMENDATION:** Code of Federal Regulations - CFR33.183.420 mandates that positive terminals be protected against accidental shorting by the use of insulation barriers or sleeves or with battery case cover. Recommend compliance with Code of Federal Regulations. **RECOMMENDATION:** Code of Federal Regulations CFR33.183.420 mandates that batteries be well secured from movement of no more than 1" in any direction with a pull force of 90 lbs or 2 times the battery weight. Recommend compliance with Federal Law. Wing nuts are used to connect battery cables to the battery terminals. **RECOMMENDATION:** ABYC E-10.8.3 recommends that battery cables and other conductors size 6 AWG and larger shall not be connected to the battery with wing nuts. Recommend compliance with ABYC. No containment tray in case of electrolyte spillage as recommended by ABYC.

Batteries not fully secured. Positive terminal(s) not covered as required. RECOMMENDATION: Code of Federal Regulations - CFR33.183.420 mandates that positive terminals be protected against accidental shorting by the use of insulation barriers or sleeves or with battery case cover. Recommend compliance with Code of Federal Regulations. RECOMMENDATION: Code of Federal Regulations CFR33.183.420 mandates that batteries be well secured from movement of no more than 1" in any direction with a pull force of 90 lbs or 2 times the battery weight. Recommend compliance with Federal Law.

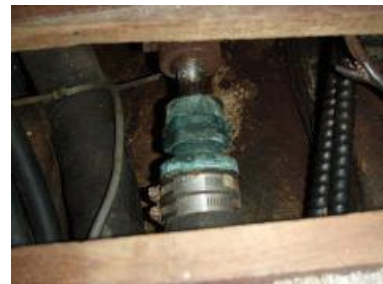
**Propeller shaft(s):** 1", Stainless steel.  
**Stuffing box(es):** Stuffing box and packing gland, bronze hex nut type, is corded but remains serviceable. Maintenance access from aft cabin.

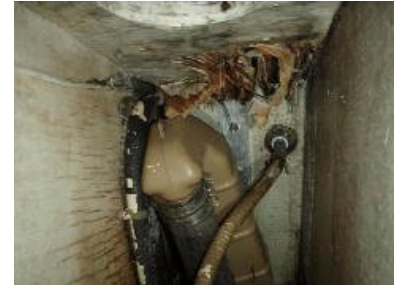
<b>Type:</b>	Cockpit Wheel steering served by cable type radial quadrant drive at rudder head.
<b>Pulley, cable, chain:</b>	No broken cable wires sighted and cable pulley / sheaves are well secured. Steering quadrant is corroded, but remains in serviceable condition. .
<b>Rudder stock(s):</b>	2" Stainless steel stock.
<b>Packing glands:</b>	No leaks sighted. <i>NOTE: Rudder packing glands should always be totally dry. Check frequently and adjust if necessary.</i>
<b>Emergency tiller:</b>	An emergency tiller was not sighted aboard but is recommended.
<b>Damage sighted:</b>	Surveyor noted that a 1 inch thick top plywood panel over the rudder stock space is rotted through and wet. The exhaust hose situated below this area is also affected. The source of water is most likely around the deck access port for the emergency tiller. Recommendation: Re-bed the access port to prevent further ingress of water. Repair / replace damaged plywood, which is integral to the construction of the deck storage boxes.

Surveyor noted that a 1 inch thick top plywood panel over the rudder stock space is rotted through and wet. The exhaust hose situated below this area is also affected. The source of water is most likely around the deck access port for the emergency tiller. Recommendation: Re-bed the access port to prevent further ingress of water. Repair / replace damaged plywood, which is integral to the construction of the deck storage boxes.

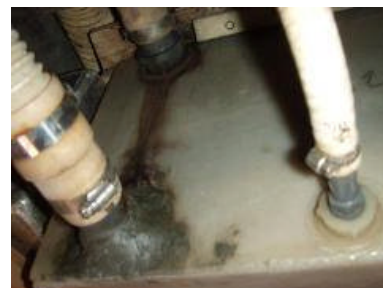
**Tank(s) secured:** Yes.  
**Tank(s) condition:** Evidence of tank leakage noted at inlet connection, and some waste water in nearby bilge area resulting in malodorous condition. **RECOMMENDATION: Remove tank, clean area and repair or replace tank or fittings as necessary.**

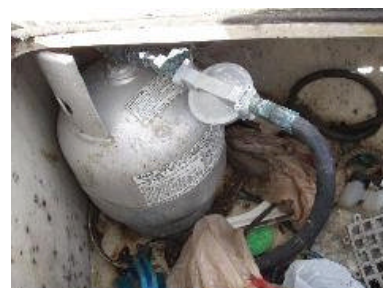
**No & location of tanks:** One tank.  
**Secured:** **Tank is not properly secured to prevent upset or displacement that could place a strain on fuel distribution or appliance fittings. RECOMMENDATION: Secure tank and hose as necessary per ABYC A-1 recommendations.**

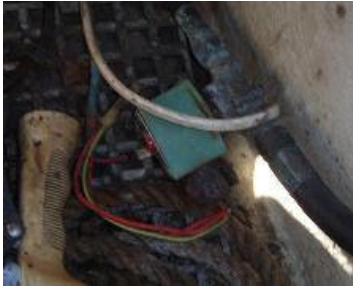
**Shut off valve(s):** LPG shut off valve at the tank top is functional. Solenoid shut off switch is rusty and not functional. Recommend installing new unit in compliance with current ABYC A-1 recommendations.

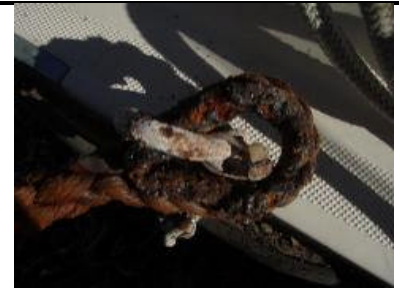
**Primary anchor:** Secured to anchor platform. **The anchor line thimble is heavily corroded and likely to fail. Recommend replacement.**
